## Process Induced Defects in Silicon Wafers

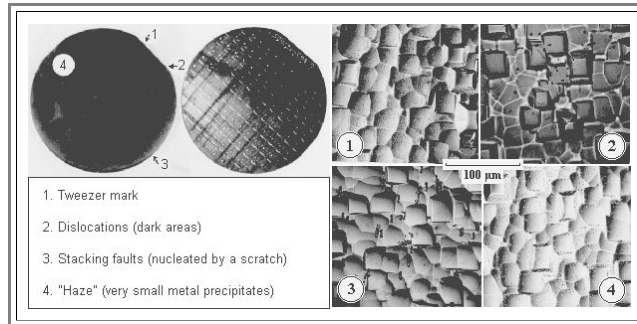
Shown is a wafer that has been processed to some extent in order to produce integrated circuits. Four kinds of defects were created that can be clearly distinguished, and (with some experience) identified as to their nature and cause of generation.

The whole view of the wafer shows the polished front side (left) where not much is visible at this size. The backside (right) has been intentionally roughened by a **KOH** etch, this accounts for the large scale structure (the intersecting approximate rectangles) in the enlargements in the second half of the picture.

The four micrographs showing the particular defects can be viewed at higher resolution. Click on the corresponding numbers.
