Defects in Transistors Revealed by Etching

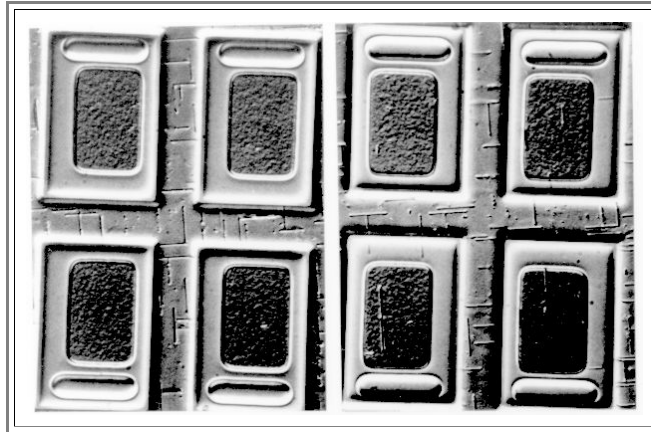
Stacking faults revealed by the so-called "**Secco etch**" for **30** seconds in transistors. For one kind of process we can see different phases of the stacking fault generation by process-induced "forces" by looking at wafers from different stages of the process:

Here we see bipolar transistors where just the collector contact (the oval part) and the base region (the rectangular part) have been defined. We have:

- Small stacking faults only outside the transistor areas (the rectangles) on the left-hand side
- Large stacking faults inside and outside the transistors on the right-hand side. These stacking faults may actually be rather complicated structures [akin to the one shown in the backbone text](#).

- The transistors without any stacking faults will work, but their leakage currents may still be considerably higher than the leakage currents in transistors without any stacking faults in the neighborhood.
- The transistor with large stacking faults in their interior will most likely not work at all. They will have a short-circuited emitter-base diode.
- The transistors with small stacking faults will mostly work, (albeit not too well), but some of them will be dead. The likelihood of "death by stacking fault" increases with the stacking fault density. This puzzle [could be solved](#) by **TEM**.

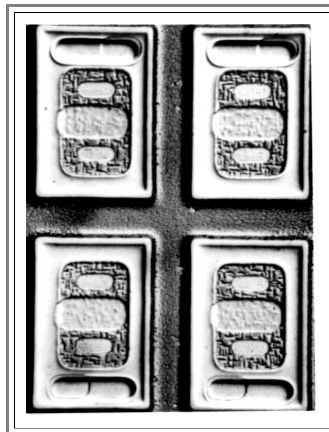
Now we have progressed to the emitter (the two smaller ovals) the base contact (the bigger oval) and the highly doped contact area of the collector (the small oval in the bigger collector contact oval)

- We have small stacking faults in high density only in the base region (including the contact). The others either vanished (unlikely) or were not produced in this wafer.
- What that looks like at [high magnifications](#) as seen by transmission electron microscopy can be seen in the link.

We also can see that the alignment of the structures to the $\langle 110 \rangle$ direction of the wafer is rather poor (the rectangles are not parallel to the traces of the stacking faults) and the alignment of the structures is not too good either (the base contact, e.g., is not at the exact center of the base).
