Defects in Transistors Revealed by Etching

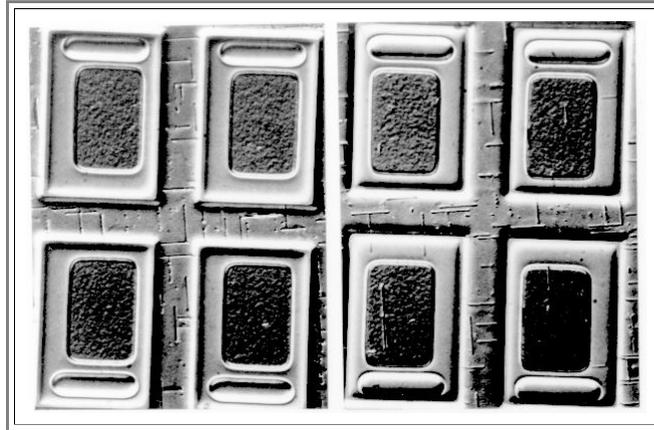
Stacking faults revealed by the so-called "**Secco etch**" for **30** seconds in transistors. For one kind of process we can see different phases of the stacking fault generation by process-induced "forces" by looking at wafers from different stages of the process:

Here we see bipolar transistors where just the collector contact (the oval part) and the base region (the rectangular part) have been defined. We have:

- Small stacking faults only outside the transistor areas (the rectangles) on the left-hand side
- Large stacking faults inside and outside the transistors on the right-hand side. These stacking faults may actually be rather complicated structures [akin to the one shown in the backbone text](#).

The question is: Will the transistors work? The answer is: It depends.

- The transistors without any stacking faults will work, but their leakage currents may still be considerably higher than the leakage currents in transistors without any stacking faults in the neighborhood.
- The transistor with large stacking faults in their interior will most likely not work at all. They will have a short-circuited emitter-base diode.
- The transistors with small stacking faults will mostly work, (albeit not too well), but some of them will be dead. The likelihood of "death by stacking fault" increases with the stacking fault density. This puzzle [could be solved](#) by **TEM**.

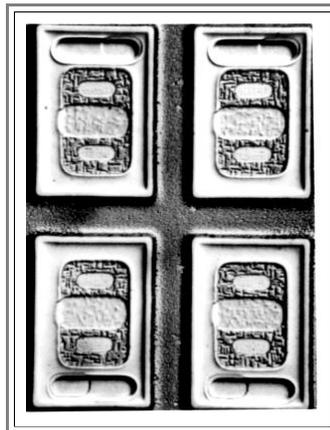
Now we have progressed to the emitter (the two smaller ovals) the base contact (the bigger oval) and the highly doped contact area of the collector (the small oval in the bigger collector contact oval)

- We have small stacking faults in high density only in the base region (including the contact). The others either vanished (unlikely) or were not produced in this wafer.
- What that looks like at [high magnifications](#) as seen by transmission electron microscopy can be seen in the link.

We also can see that the alignment of the structures to the $\langle 110 \rangle$ direction of the wafer is rather poor (the rectangles are not parallel to the traces of the stacking faults) and the alignment of the structures is not too good either (the base contact, e.g., is not at the exact center of the base).
